# PC1XX-FA TO PC500

## TECHNICAL INFORMATION

Tech Tip Index

| <b>Title</b><br>PC100 TECHNICAL CHARACTER SET CAUTION | | | | | <b>Tech Tip No.</b><br>PCLXX-FA-TT-01 | | |

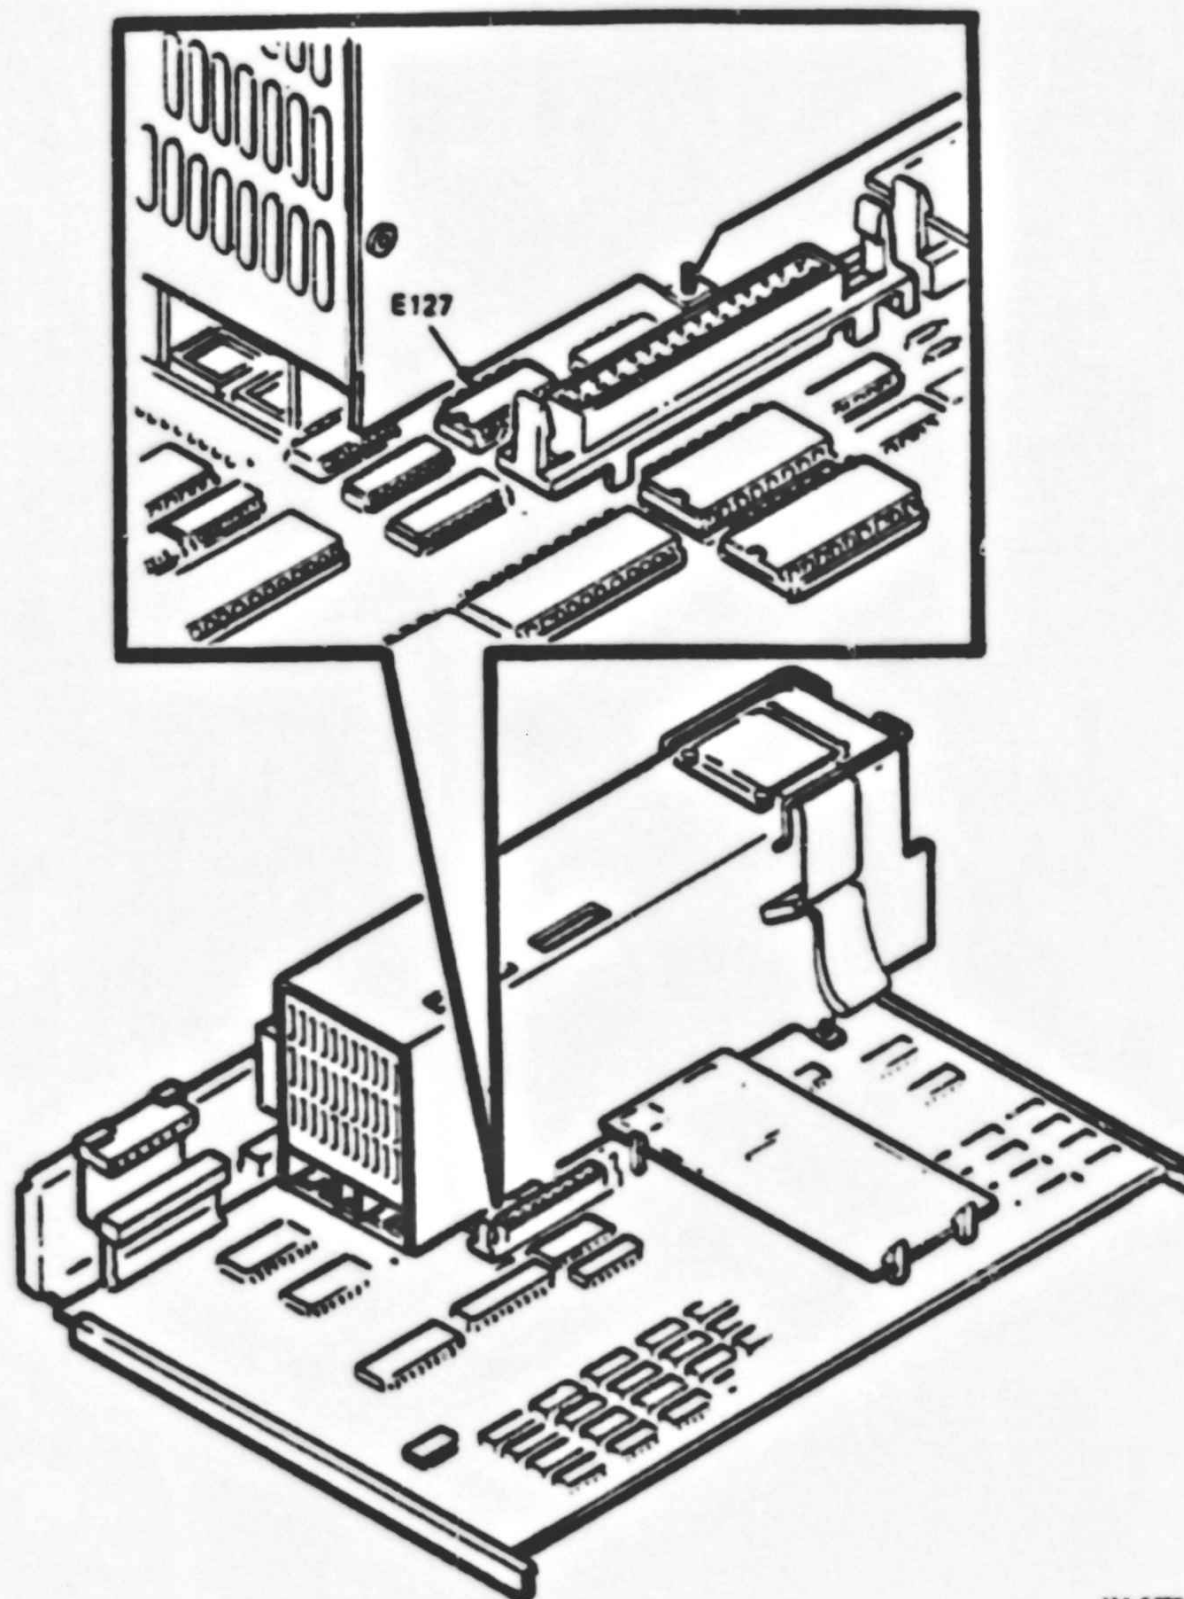
Piracy Protected Applications Software installed on the PRO 325, PRO 350, PRO 380 and PRO IVIS will not run after the System Module is replaced. This happens because the number programmed in the ID PROM on the replacement System Module does not match the ID number the software expects to see.

(Figure 1) KDF11-CA/CB/CC ID PROM LOCATION "E127"

FIELD SERVICE - IF THE SYSTEM MODULE IS A C.S. REV F OR LATER THE ID ROM IS SOCKETED (LOCATION E127, 18 PIN SOCKET) AND SHOULD BE REMOVED FROM THE DEFECTIVE SYSTEM MODULE AND INSERTED INTO THE REPLACEMENT SYSTEM MODULE.

Whenever a KDF11-CA/CB/CC or KDJ11-CA System Module is replaced, swap the ID PROMs.

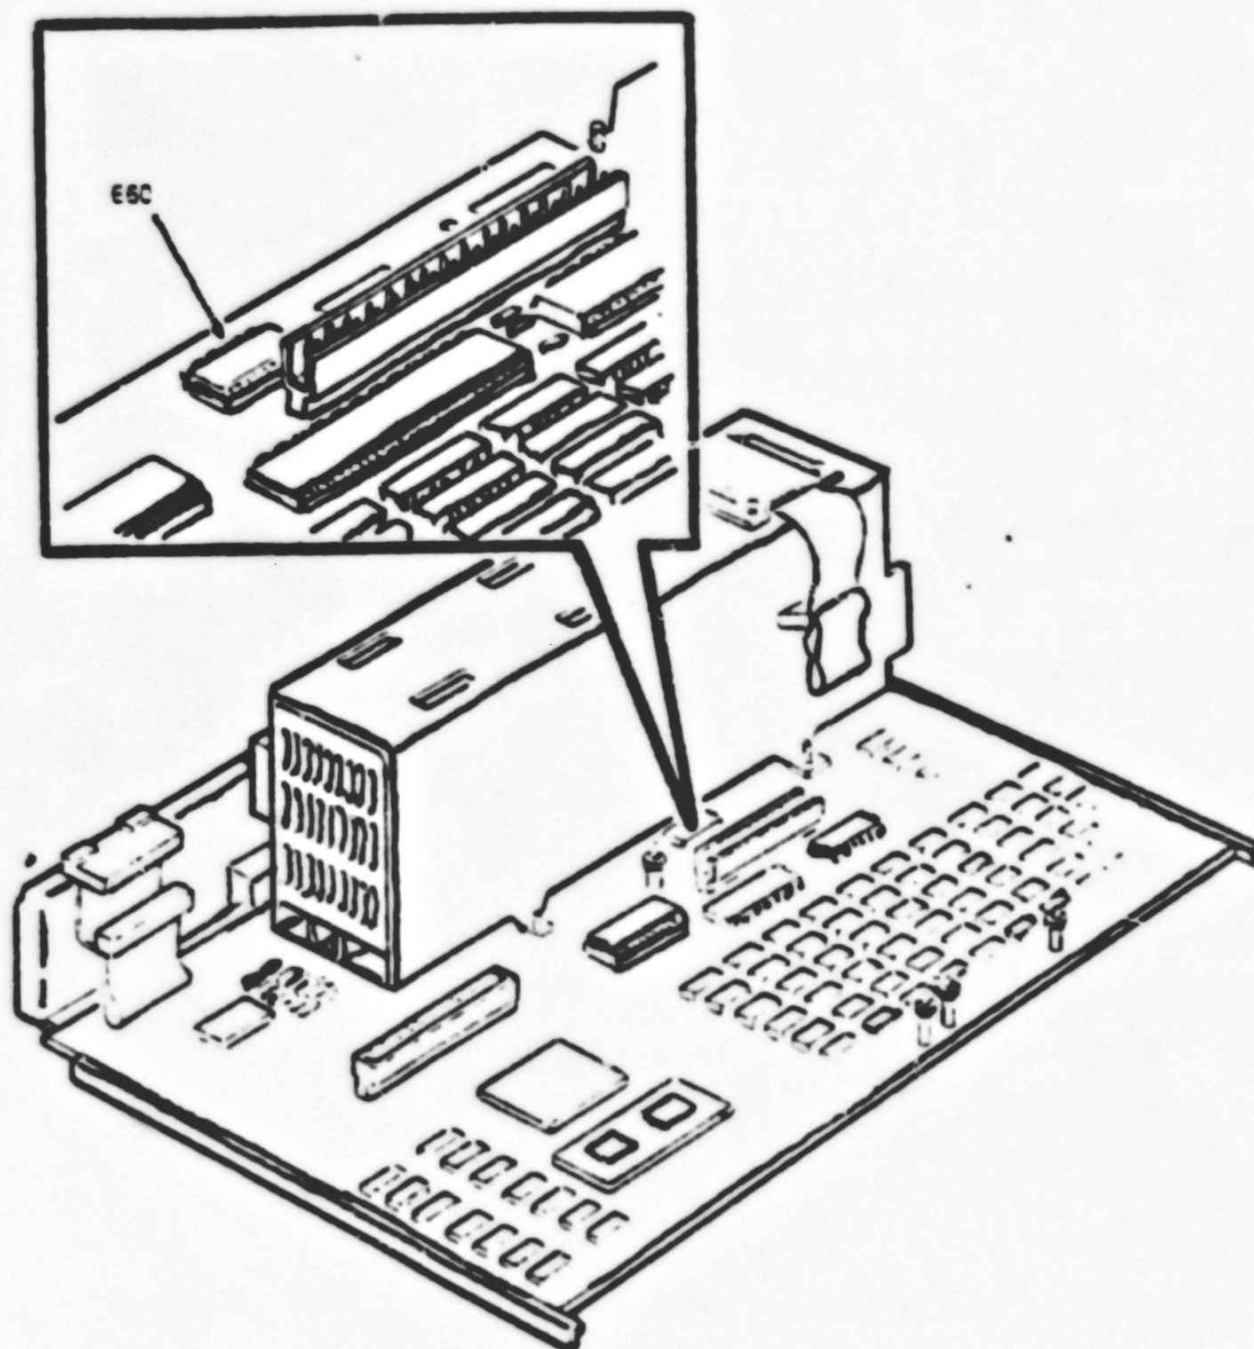
(Figure 2) KDJ11/CA ID PROM LOCATION "E60"
